A Preliminary Report Of The San Fernando Earthquake In
Relation To Highway Damage

Business and Transportation Agency
Department of Public Works
Division of Highways

Preliminary Report

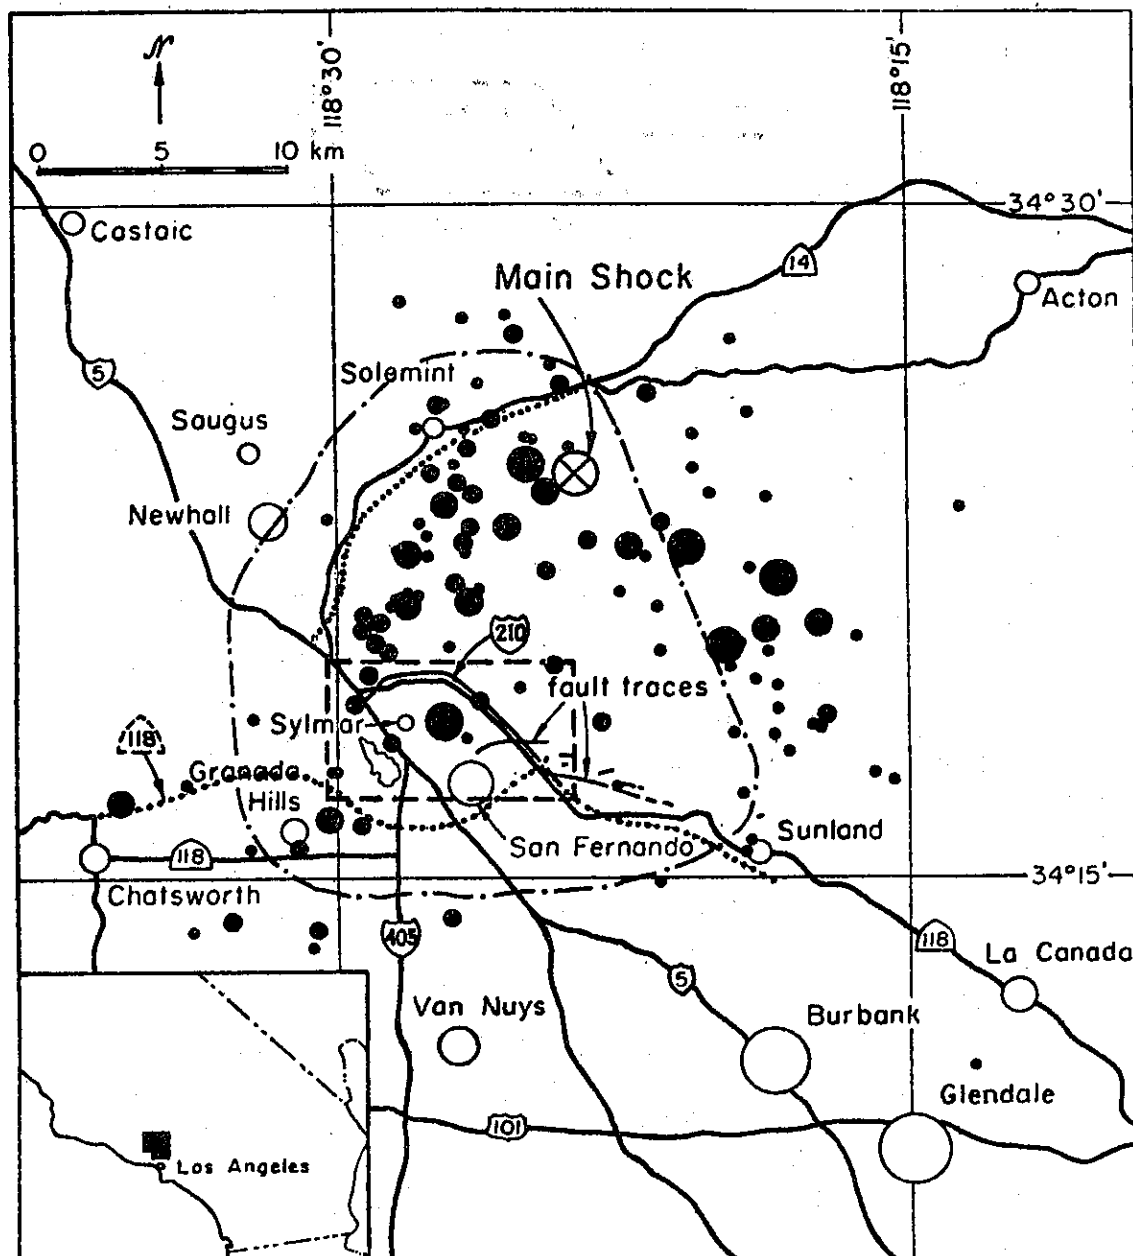
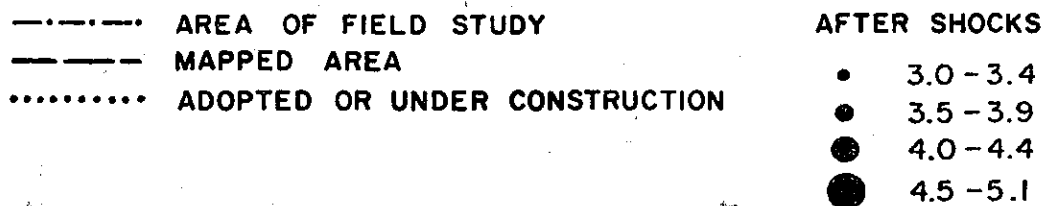
**Figure 1 GENERAL AREA OF FIELD STUDY,
MAPPED AREA, AND AFTERSHOCKS**

shape formed by the aftershock locations shown in Figure 1, that moved to the south and west along a thrust fault plane dipping about 45° to the north. This upper plate moved over the lower plate as rupture progressed along the thrust plane from the hypocenter to intercept ground surface in the Sylmar-San Fernando area. Because of the shallow fault depths and large ground displacements, this was the area in which damage to engineering works was concentrated.

Continuing studies of the aftershocks by Cal Tech seismologists are contributing to the overall picture of tectonic movement. These shocks, with an average focal depth of about four miles (maximum eight miles), have been divided into the eastern group, the epicentral group, and the Chatsworth group (Figure 1). According to Hanks, et al, (1) the focal depths of the eastern group are fairly shallow and are above the thrust plane as defined by the epicentral group (Figure 2b). Depths of the Chatsworth group, on the other hand, are deeper than the thrust plane. Based partly on this information, Whitcomb (2) has suggested a model to describe the overall movement.

A geologic investigation of earthquake damage to roads in the San Fernando Valley area was begun on February 19 and is still in progress. The area being studied is shown in Figure 1 and consists of the northern portion of the San Fernando Valley and the Newhall-Solemint Junction area northeast of and separated from the San Fernando Valley by the San Gabriel Mountains. This is the area in which damage to freeways, private dwellings, and other structures was concentrated, although scattered damage (generally not involving roads) did occur in other areas of metropolitan Los Angeles.

The mapped area is shown in Figure 1, and will be referred to later as the "map area." Practically all faulting and other ground breakage that affected major highways occurred in the map area.

Six major roads (five freeways and one State highway) traverse the earthquake affected area as shown in Figure 1. The most important single road is Interstate Route 5 (Golden State Freeway) which is the main north-south artery for traffic entering and leaving the northern metropolitan Los Angeles area. Interstate Route 405 (San Diego Freeway) junctions with Route 5 in the northern San Fernando Valley to provide a more direct north-south route through the metropolitan area westerly of downtown Los Angeles. About 2.2 miles north of the Route 5/405 junction, Route 5 interchanges with Interstate Route 210 (Foothill Freeway) at the southern base of the San Gabriel Mountains. Route 210 is a new freeway with only five miles having been completed in the general area. East of Maclay Avenue, where pavement ends, only fills have been constructed for another two miles. This route will be a perimeter facility beginning at Route 5 and skirting along the northern and eastern fringes of the metropolitan area paralleling and very close to the base of the San Gabriel Mountains.

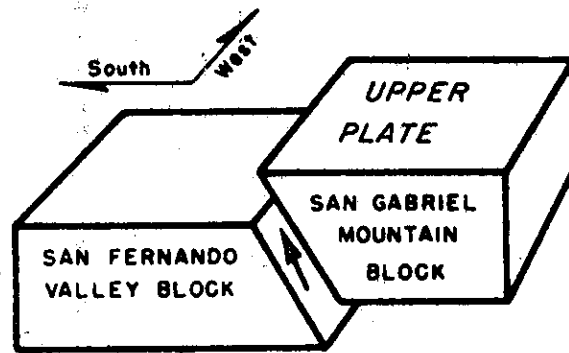
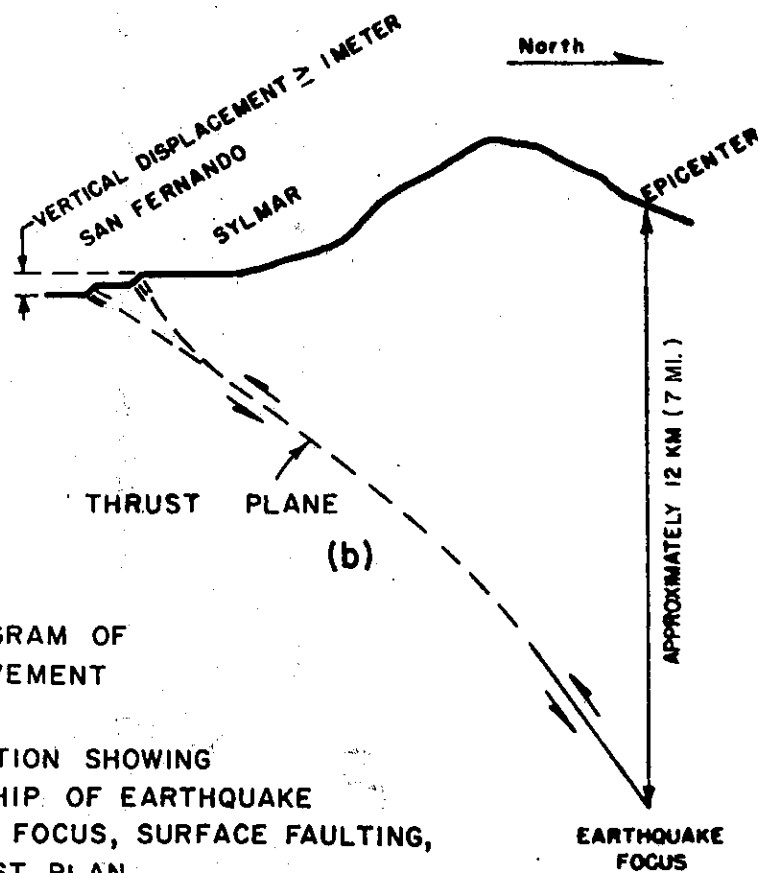
(a) BLOCK DIAGRAM OF
FAULT MOVEMENT
